Fire Risk Assessment

Monxton Place

09 Sep 2020

1. Risk Summary
2. Risk Assessment
 - Health, Safety and Environmental Policy
 - Organisation
 - Management of Health & Safety
 - Measuring Performance
 - Site Inspection
3. Action Plan
4. Archive

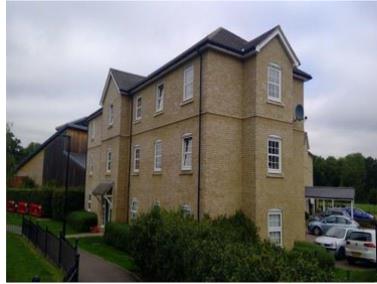
Monxton Place is a purpose built residential block of flats consisting of ground floor, first floor and second floor. There are 9 flats in total (30-46) and all flats are accessed through two main entrances. The building is constructed with pitched roof, wooden soffits, brick walls. There is a car park at the rear of the building. A single stairwell runs from the second floor down to the ground floor exit at the front of the building and all flats open onto the escape route. Ground floor flats have alternative escapes at the rear of the building. There are fire lobbies at each floor level between the flat entrances and the escape stairwell. Electrical intake cupboards are located on each floor. There is a bin store located externally remote from the building. Gas services are housed externally in plastic cabinets.

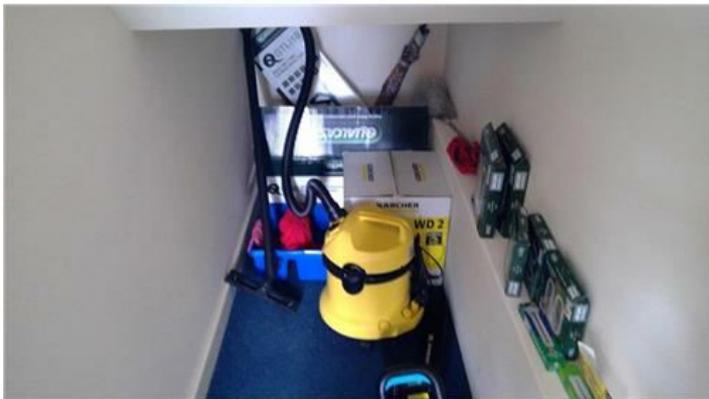
WIN_20200909_11_27_50_Pro.jpg

Ref	Sub Section	Question	Non-conformity	Recommendation	Location	Who is responsible	By When
11721094	M	Are house keeping arrangements satisfactory?	Poor housekeeping has resulted in an accumulation of rubbish, waste paper or other materials that could catch fire or be set alight.	Ensure an adequate housekeeping policy is implemented, consolidated with periodic management inspections.	Ground floor cupboard under stairs	Recommendation for Client	27/12/2020
